Manhole Inspection Summary

Manhole # S04CC2003MH

Location Address: **3600 PARK HEIGHTS AVE** Cross Street: **LABYRINTH RD**

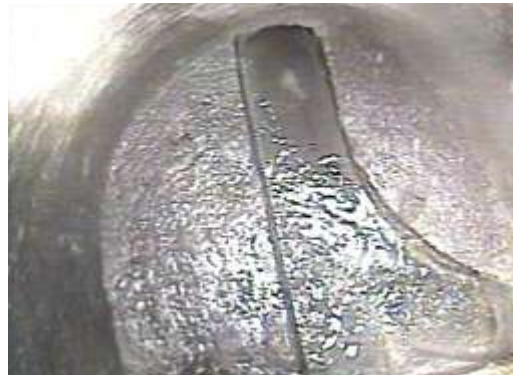
Top View

Adjustment infiltration.

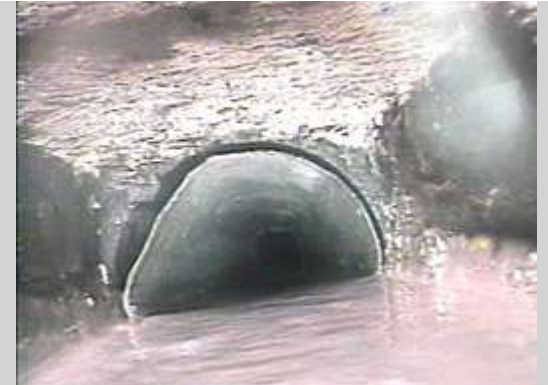
10 in. Circular Gravity Sewer Pipe Out @ 12 O'Clock

Comments **This MH may has been rehabbed but it appears that the cemittitious lining towards the bottom of the Barrel is thin and the O12 pipe liner is not adhering to the pipe opening.**

Pipe Material: **Clay** ☒ Pipe Lined

Invert Depth: **6.68** (ft.) Flow Characteristics: **Fast**

Infiltration: **None** Pipe Seal Cond: **Unknown**

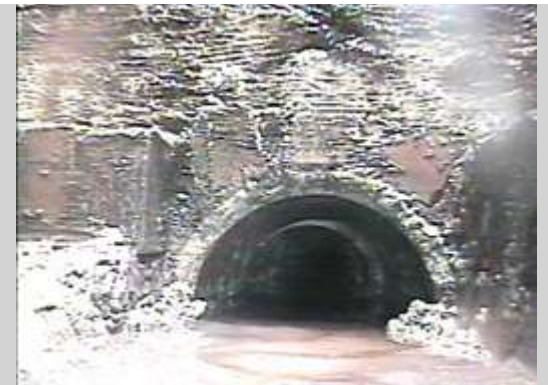
10 in. Circular Gravity Sewer Pipe In @ 4 O'Clock

Pipe Material: **Clay** ☐ Pipe Lined

Invert Depth: **6.58** (ft.) Flow Characteristics: **Fast**

Infiltration: **None** Pipe Seal Cond: **Unknown**

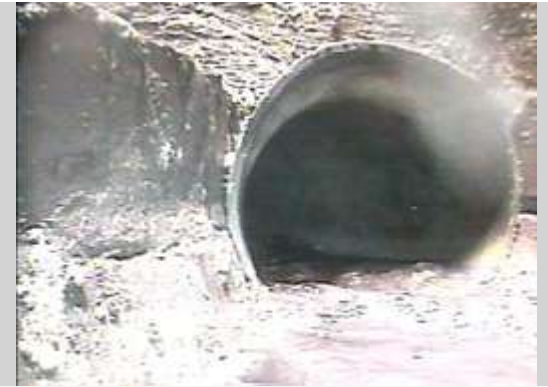
8 in. Circular Gravity Sewer

Deposits: ☐ None ☐ Mud ☐ Sludge ☒ **Debris** ☐ Grease

Silt Depth: **1** (in.)

Deposits Extent: **Light**
